Demonstrate and Evaluate Saturated Buffers at Field Scale to Reduce Nitrates and Phosphorus from Subsurface Field Drainage Systems

NRCS CIG: Grant # 69-3A75-11-205

Date of Submission: December 15, 2015

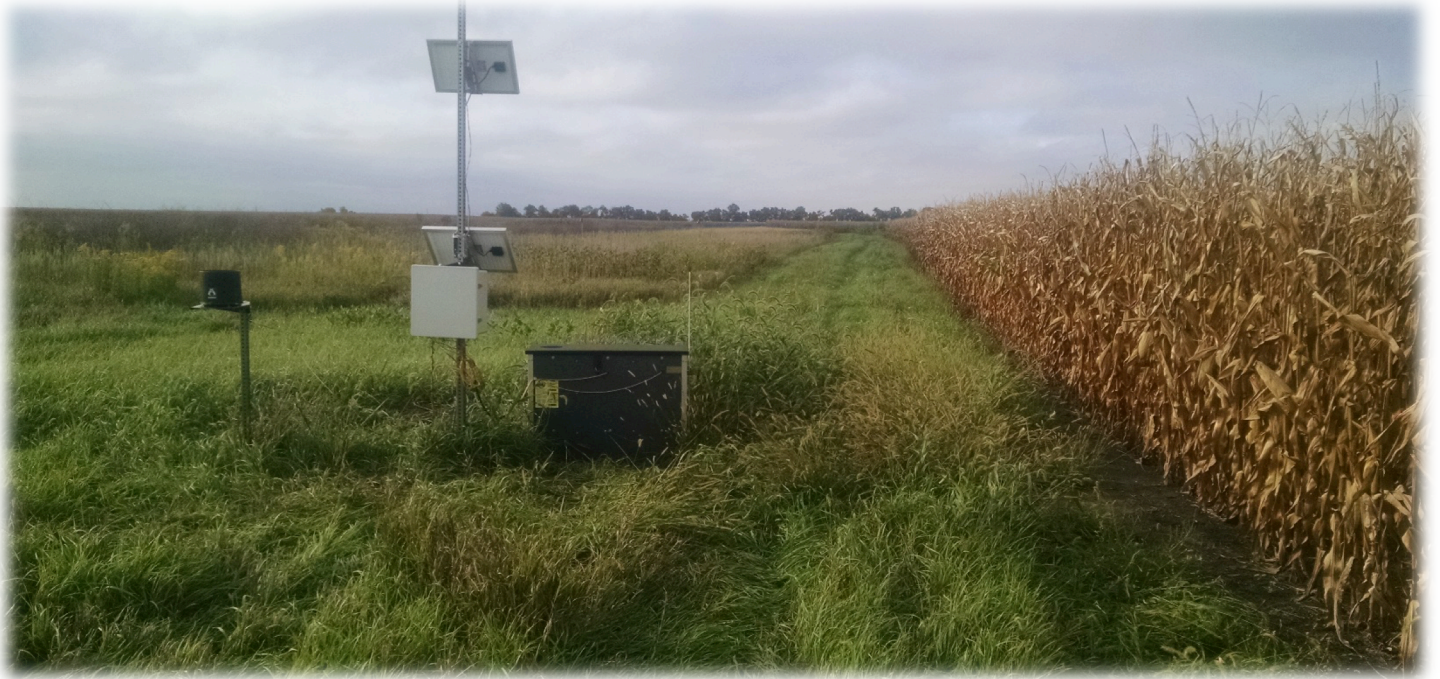
A Saturated Buffer in Illinois (IL-3)

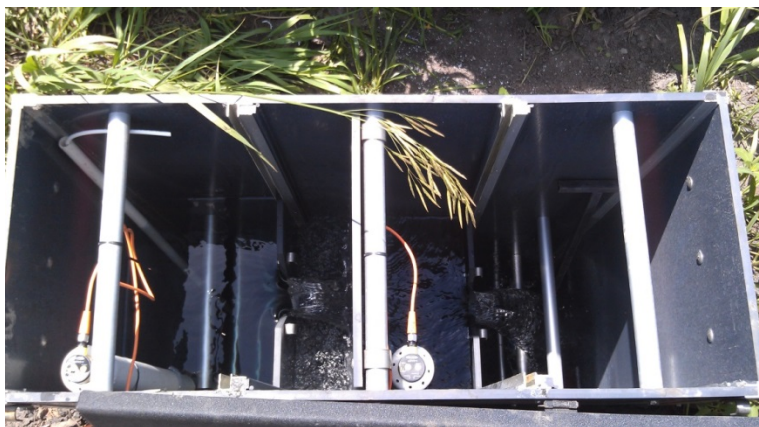
A typical control structure, equipped with water level sensors, v-notch weirs, and splash guard between chambers

Tile flow was monitored using v-notch weirs that were installed inside the three-chambered (two sets of stop logs) water level control structures installed (see image below) as part of the SB practice. The exception to this was the site IL-2, which will be discussed later in this section. The special v-notch stop logs used were manufactured by Agri Drain Corp (ADC). The geometry and thickness of the ADC v-notch is slightly different than a standard 45° v-notch. A rating curve for that specific geometry was developed by Dr. Richard Cooke (University of Illinois Urbana-Champaign). Additional flat-weir rating curves had also been developed for the ADC control structures by Dr. Cooke. During periods when the water level was higher than the top of the v-notch the two equations were combined. The rating curve equations, as well as instructions on to apply them, can be found in Appendix H.

The SB distribution line was connected to the chamber between the two sets of stop logs. Tile flow from the field was measured using the v-notch in the first set of stop logs. The v-notch in the second set of stop logs, which was always at least five inches lower than the first v-notch, was used to measure the bypass flow. The difference in these two flow values is assumed to equal the amount of flow that was diverted

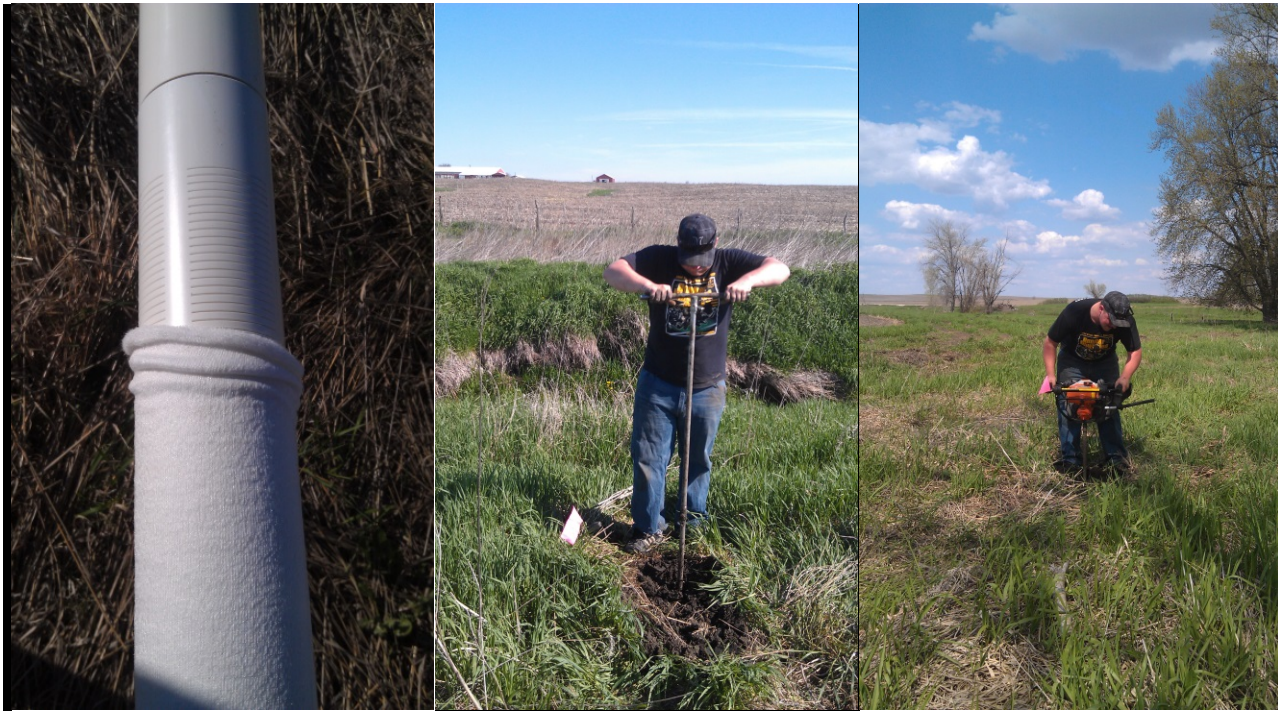
The wells comprised of a 5' section of slotted 2" PVC pipe that was wrapped in a knitted nylon fabric, as shown in the images below. A non-slotted 2' section of pipe was used to bring the pipe above the ground surface for access. The wells were typically installed between 5.0 and 6.0 ft deep. Some sites had shallower wells due to excessive stones or rock in the soil sublayers. The depths for each well is included in the individual site description (see Appendix A).

Example slotted PVC well with fabric cover and example installation.

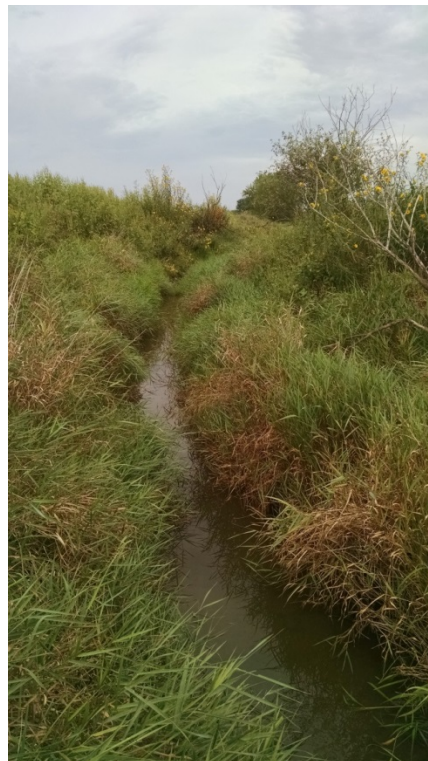
A typical section of the IN-2 ditch

Detailed transects of the drainage ditches at two of the saturated buffer sites were measured to determine if implementation of the practice had any effect on stream bank stability. These two sites were selected because the ditches were relatively deep and the banks were steep but uniformly sloped, making accurate mapping of the banks feasible. The ditch banks were also free of trees and other shrubs that could block the GPS signal needed for the survey.

At both locations three ditch transects within the saturated buffer area were intensively surveyed. The transects were equally spaced along the length of the buffer and corresponded to the well transects. Three additional transects were surveyed outside of the saturated buffer so that bank movement resulting from the SB practice could be separated from bank movement that occurs under normal conditions.

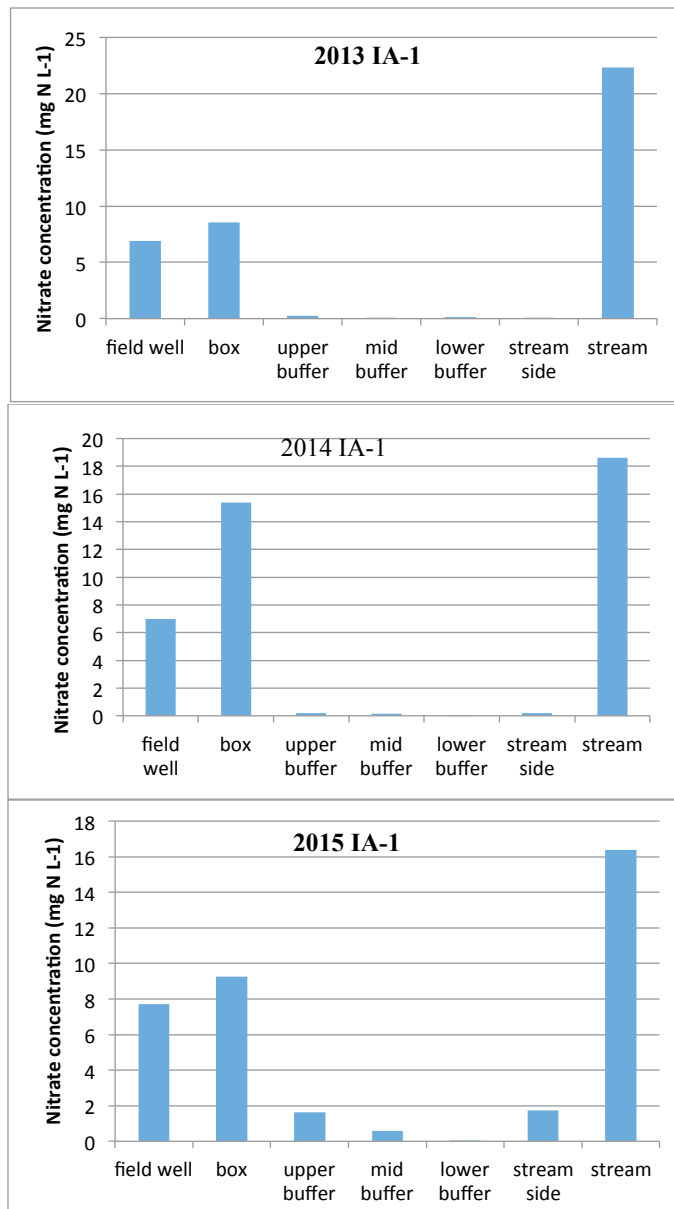
IA-1. Average nitrate concentrations by well position were computed for 2013-2015. This site had additional wells on the field side of the distribution pipe and observation wells at four positions between the stream and the distribution pipe. Average nitrate concentrations in the stream were greater than 16 mg L⁻¹ each year indicating considerable nitrate contamination in this small stream. At the control box at the tile outlet, average nitrate concentration exceeded 8 mg L⁻¹ in the tile outlet for all years. The observation wells to the field side of the distribution pipe had average nitrate concentrations exceeding 6 mg L⁻¹ – not as high as in the tile, but still indicating substantial nitrate leaching below the root zone of the row crop. Average nitrate concentrations decreased sharply to near 0 in the observation wells within the buffer. Only in 2015 did average nitrate concentrations in the buffer wells exceed 1 mg L⁻¹. Thus, this buffer appears to be removing nitrate from the shallow groundwater as it flows through the buffer.

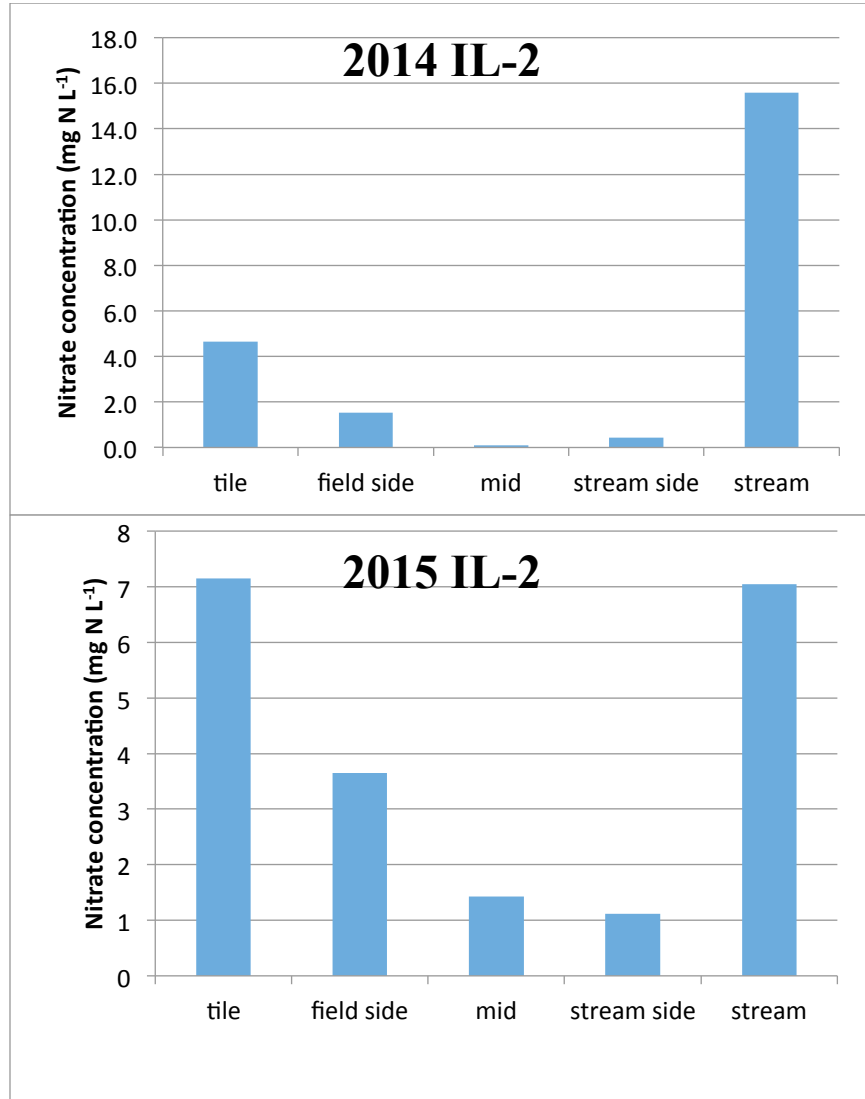
IL-2. In both 2014 and 2015 the average nitrate concentration decreased from the field side to stream side of the buffer and were much less than concentrations in the tile outlet or the stream. Thus, there appears to be the potential for nitrate removal within this buffer.

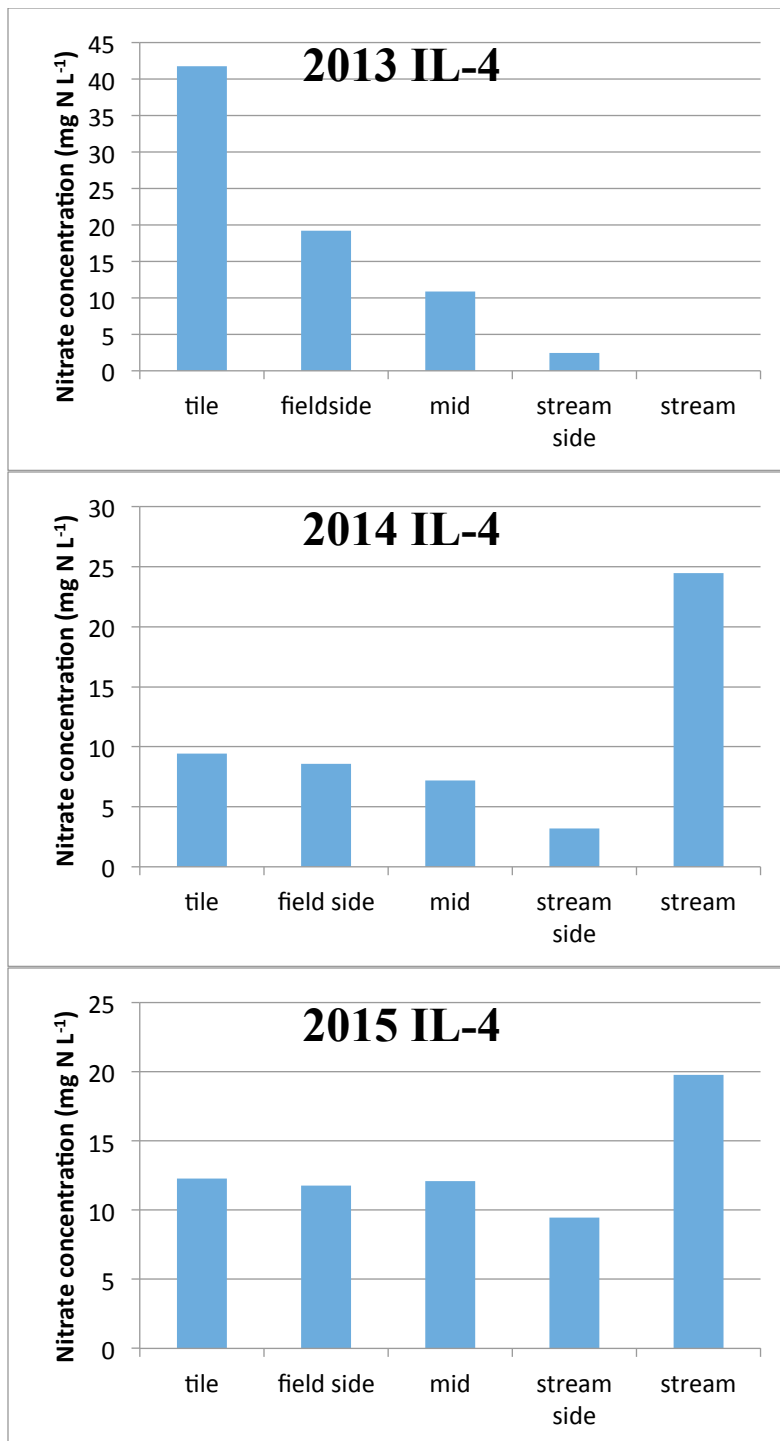
IL-4. Water samples were collected at this site in 2013-2015. In 2013, no stream samples were collected. Nitrate concentrations leaving the field were greater than 40 mg L⁻¹ in 2013, but considerably lower in 2014 and 2015. Average nitrate concentrations in 2013 for the buffer wells showed a marked decrease across the buffer indicating that nitrate removal may be taking place. A decreasing trend was also observed in 2014 although not as strong as in 2013, while very little trend was evident in the well observations for 2015. Thus, this site appeared to remove nitrate more effectively in 2013 and 2014 than in 2015.

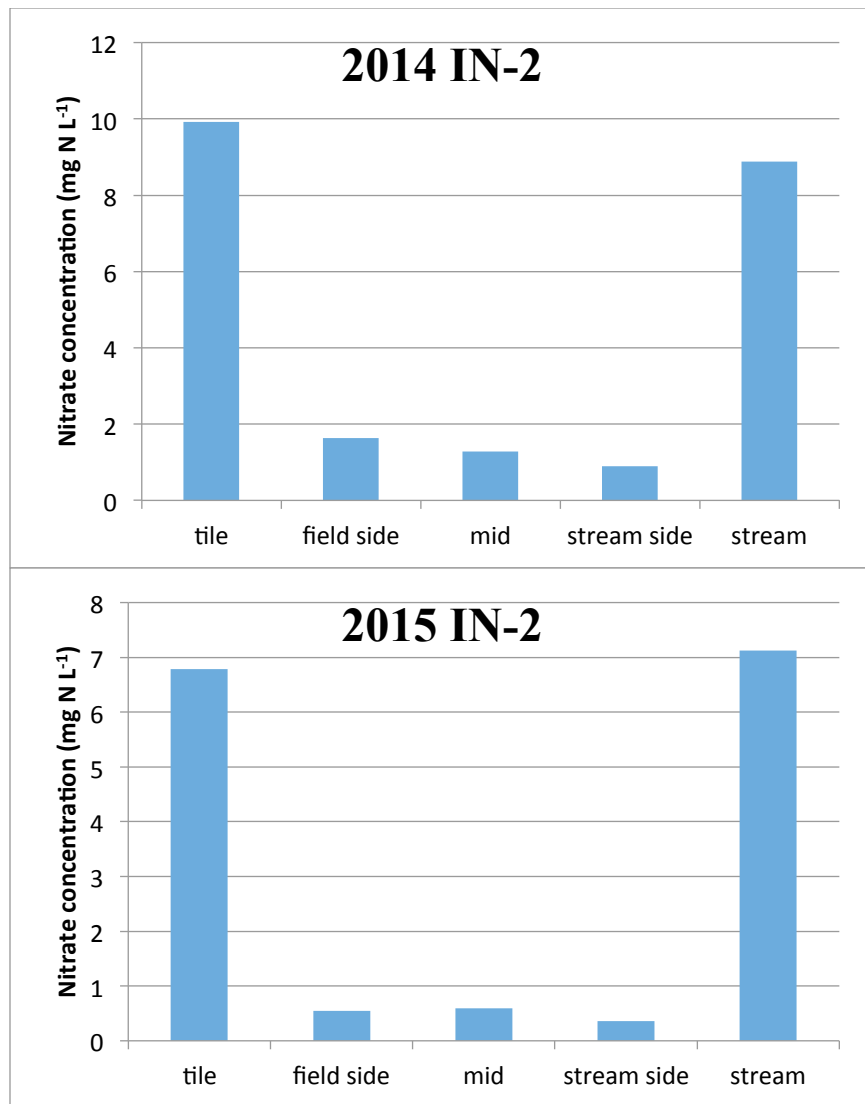
IN-2. Average nitrate concentrations at this site were similar to IN-1 where concentrations were greatest in the tile outlet and the stream and much less in the buffer wells, but there was little trend in concentration across the buffer. Thus, most of the nitrate removal would have had to take place between the distribution pipe and field side wells or the water within the buffer.

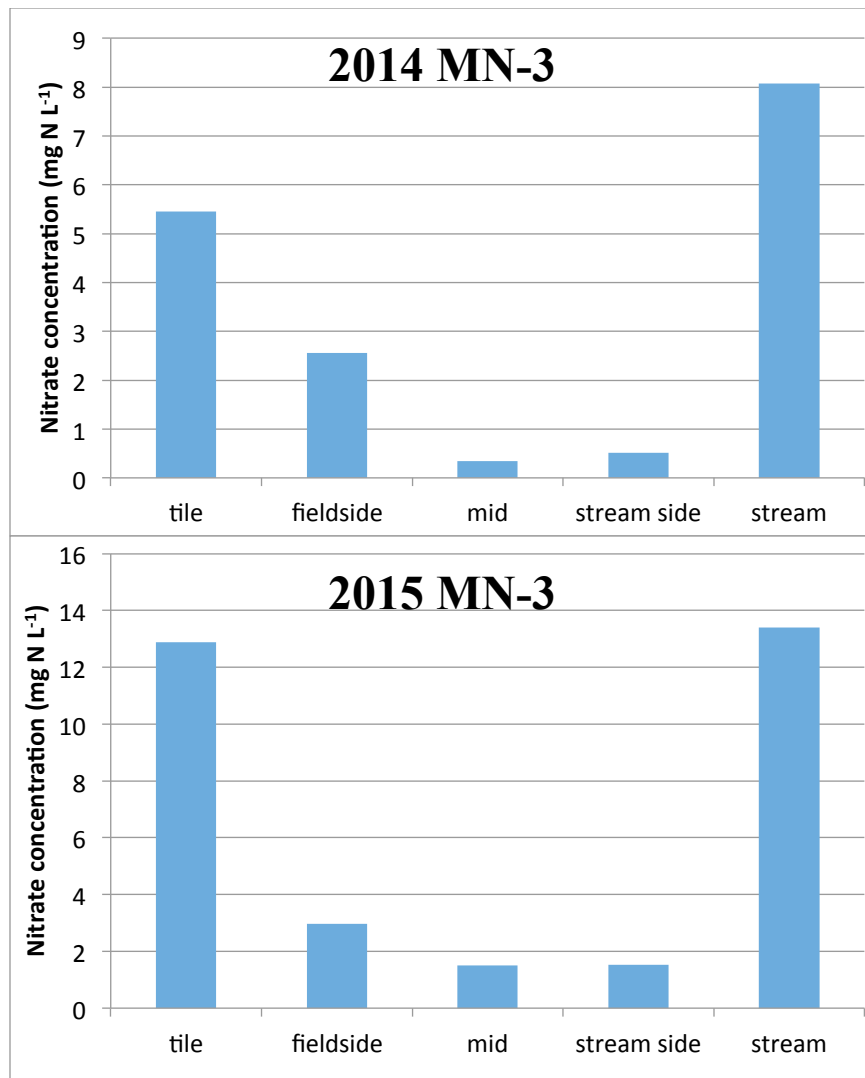
MN-3. Average nitrate concentrations showed decreasing nitrate concentrations from the field to stream side observation wells demonstrating substantial nitrate removal. Well concentrations were much less than concentrations in the tile outlet or stream. Thus, this site appears to be effective in removing any nitrate that was introduced through the distribution pipe.

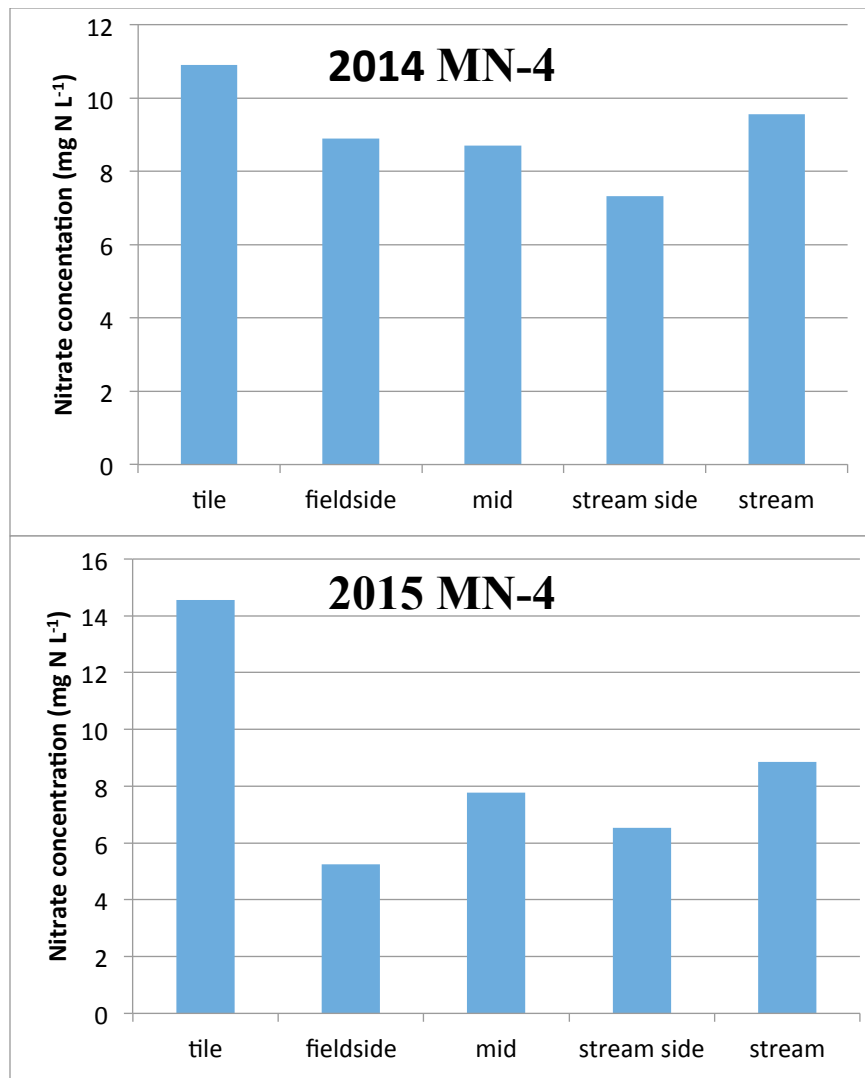
MN-4. Water samples were routinely collected from all wells at this site except for well 23 that was dry half the time in both years. This well was installed about a foot shallower than the other wells at this site and this may have contributed to less frequent collection of samples. In 2014, the average nitrate concentrations showed a modest decreasing trend across the buffer compared to the other sites, indicating some nitrate removal but by no means complete removal. In 2015, there was little evidence of trend across the buffer although nitrate concentrations were lower in the buffer than at the tile outlet, thus we conclude that nitrate removal may have been uneven and modest at this site.

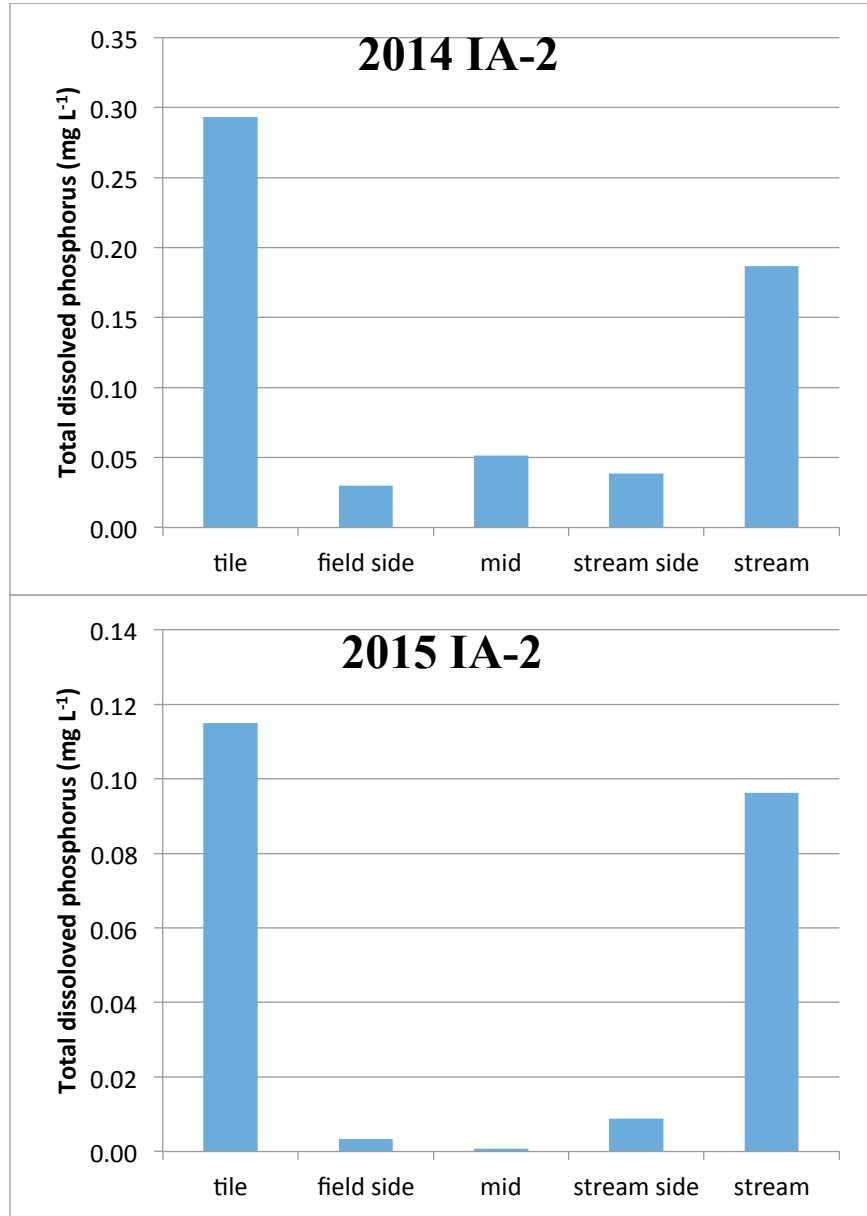
IA-2. TDP concentrations from this field tile outlet were above the 0.1 mg L⁻¹ EPA recommendation for total P. There is a marked reduction in TDP within the buffer compared to the source water from the field tile outlet. Thus, it appears that much of the TDP being introduced into the buffer is being retained in the buffer soil.

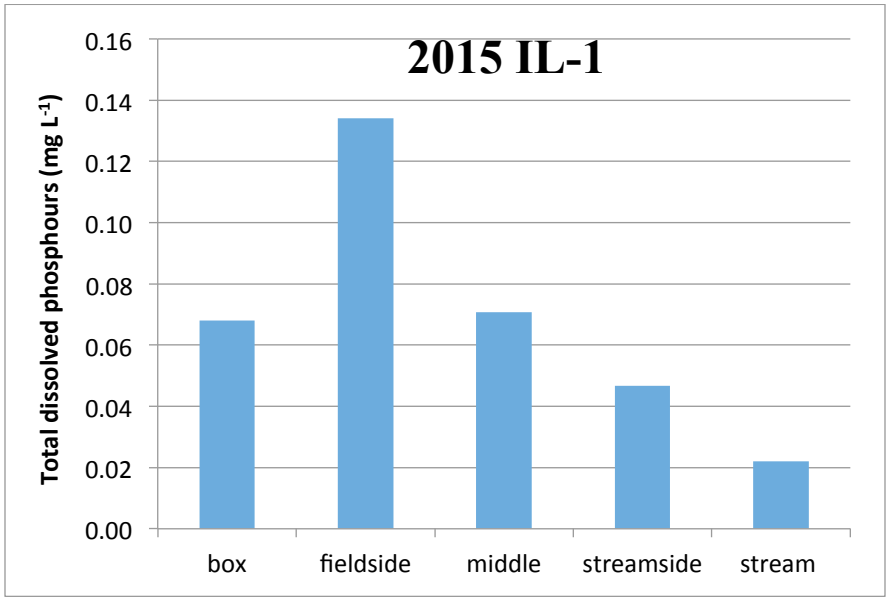
2014 IL-1
No data

IL-1. Only one water sample was collected in September of 2014 for this site (see section on Nitrate for explanation), so average TDP concentrations were not computed for 2014. In 2015, there appeared to be a trend across the buffer, but the average TDP concentration within the buffer on the field side, was greater than the average TDP coming from the tile outlet. This may be due to some legacy practice within the field, but complicates the interpretation of the pattern. This site maybe removing some TDP as shallow groundwater flows across through the buffer. The average TDP concentration in the field tile outlet was well below the 0.1 mg L⁻¹ EPA recommendation.

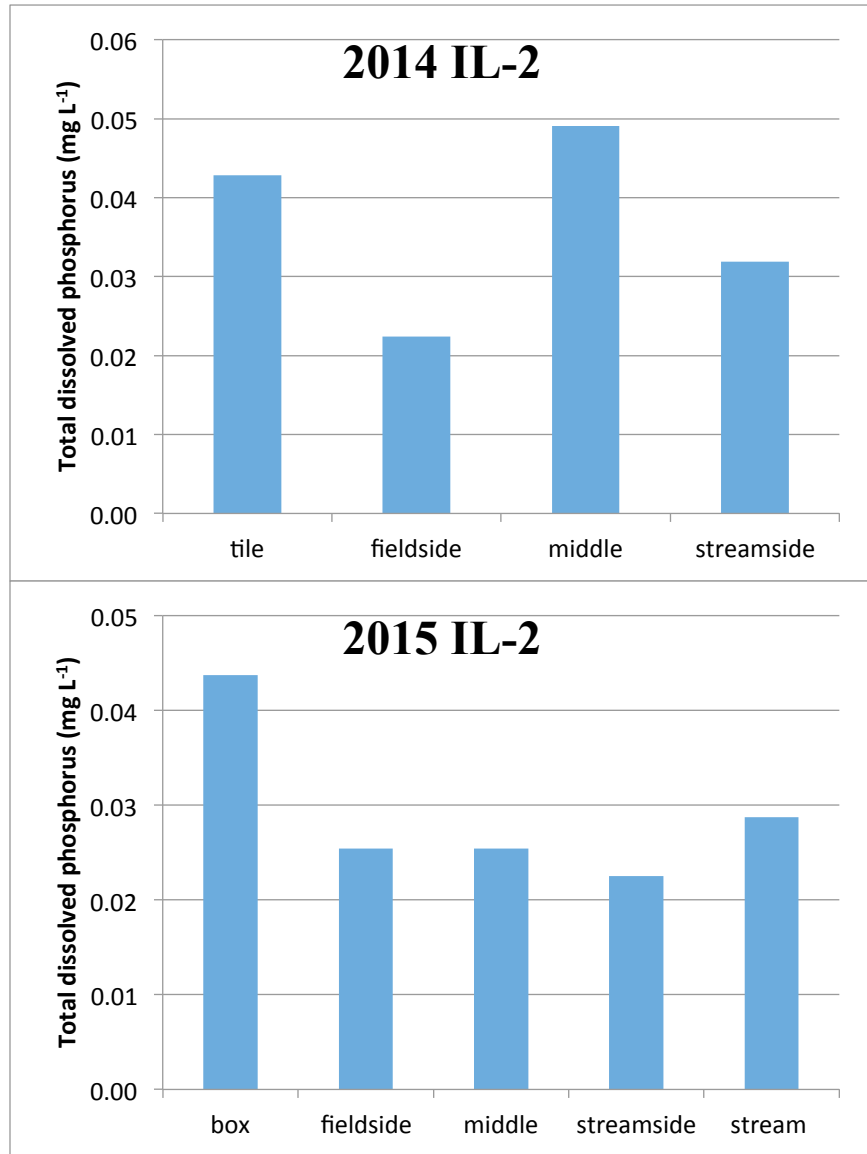
IL-2. There was no trend in TDP across this buffer in 2014, while there does appear to be some reduction in TDP within the buffer in 2015, but again little trend. Our conclusion is that this site is not effective in removing P. The average TDP concentration within the tile outlet did not exceed 0.05 mg L⁻¹, well below the EPA recommendation, thus this tile contributes little to eutrophication of the stream.

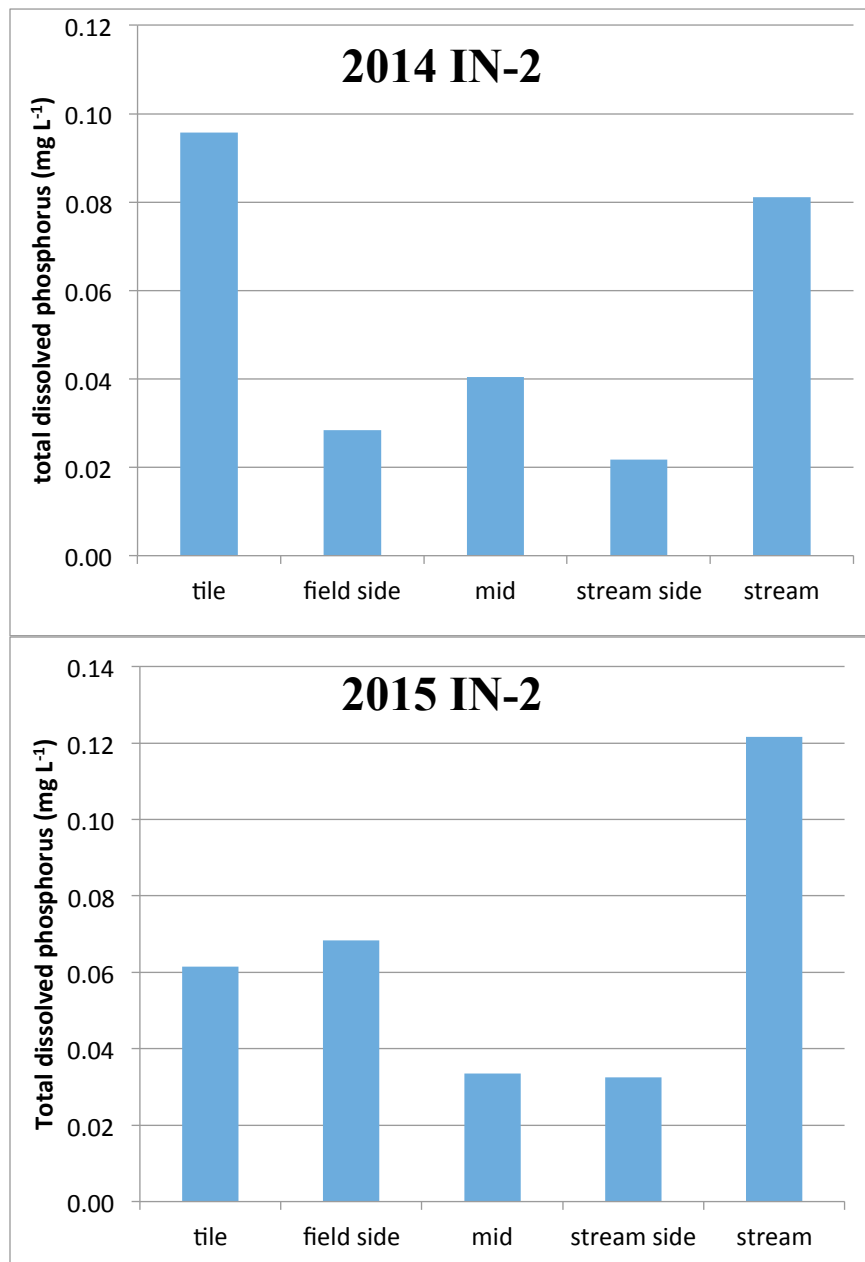
IN-2. Average TDP concentration leaving the field in the tile outlet was below the EPA recommended concentration for total P in both years. Average TDP concentrations within the buffer showed no trend or consistent pattern between the two years. We conclude that this buffer was probably not removing P.

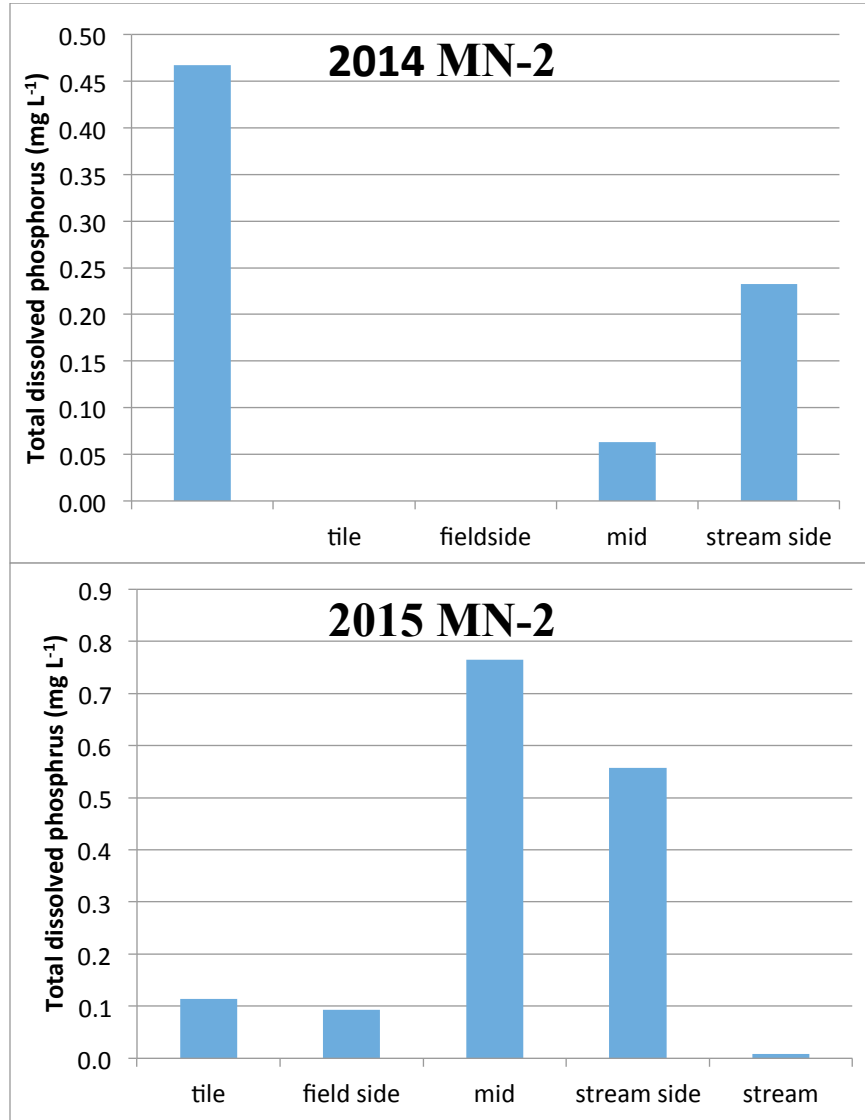
MN-2. Although water samples were collected for 7 dates in 2014, no samples were collected from transect 3 or well 11 and only 1 sample from wells 21 and 22. Only well 13 consistent had water samples, thus the results are very incomplete and difficult to interpret for 2014. Similarly, no water samples were submitted for well 31 and only samples from 2 of the 5 sample dates for wells 11, 21, 32, and 33 in 2015 leading to sparse sampling results. The lack of water samples from well 31 was most likely due to the shallow depth of installation of this well (3.38'), but we are uncertain as to why the other wells were often dry. As a result we could not determine a pattern for average TDP concentrations in the buffer wells for 2014. In 2015, average TDP concentrations were higher for some of the buffer well positions than for the tile or stream. We conclude that there was no P removal in this buffer.

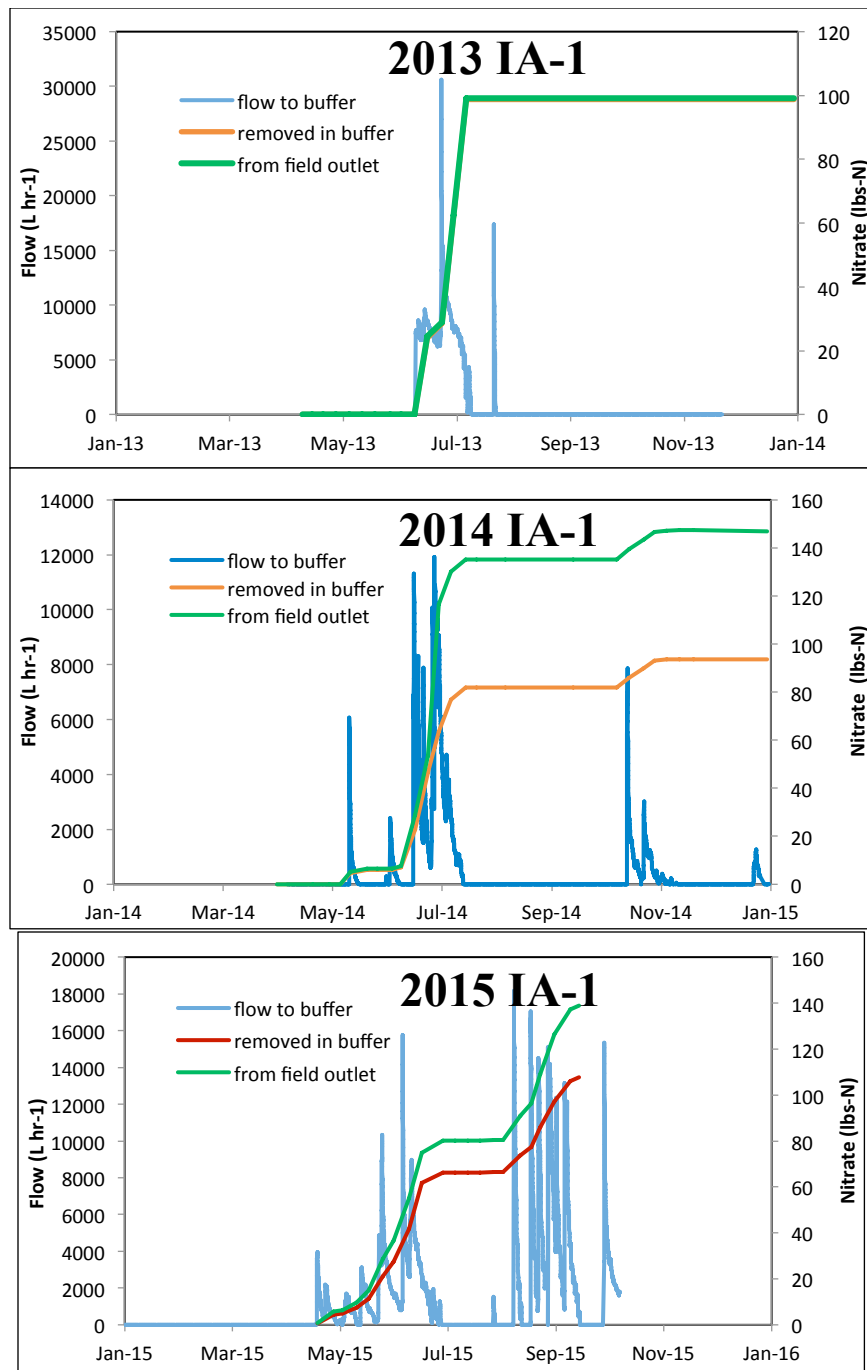
IA-1. Nitrate was removed in the buffer each year. In 2013, flow was not measured until mid-June so only nitrate removal within the buffer for the 2nd half of the year was computed that year. For the 2nd half of 2013, 100% of the nitrate entering the buffer was removed which totaled 99 lbs of nitrate N (green and red lines fall on top of each other). In 2014, 94 lbs of N as nitrate or 64% of the 147 lbs of nitrate-N delivered to the field outlet was removed in the buffer. In 2015, 139 lbs of N as nitrate was carried to the outlet and 107 lbs or 77% of nitrate-N was removed in the buffer. For these years 100, 64, and 91% of the flow from the field was redirected into the buffer. Thus, over the 2½ years at this site 301 lbs of nitrate was removed in the buffer – nitrate that would have otherwise discharged directly into the stream.

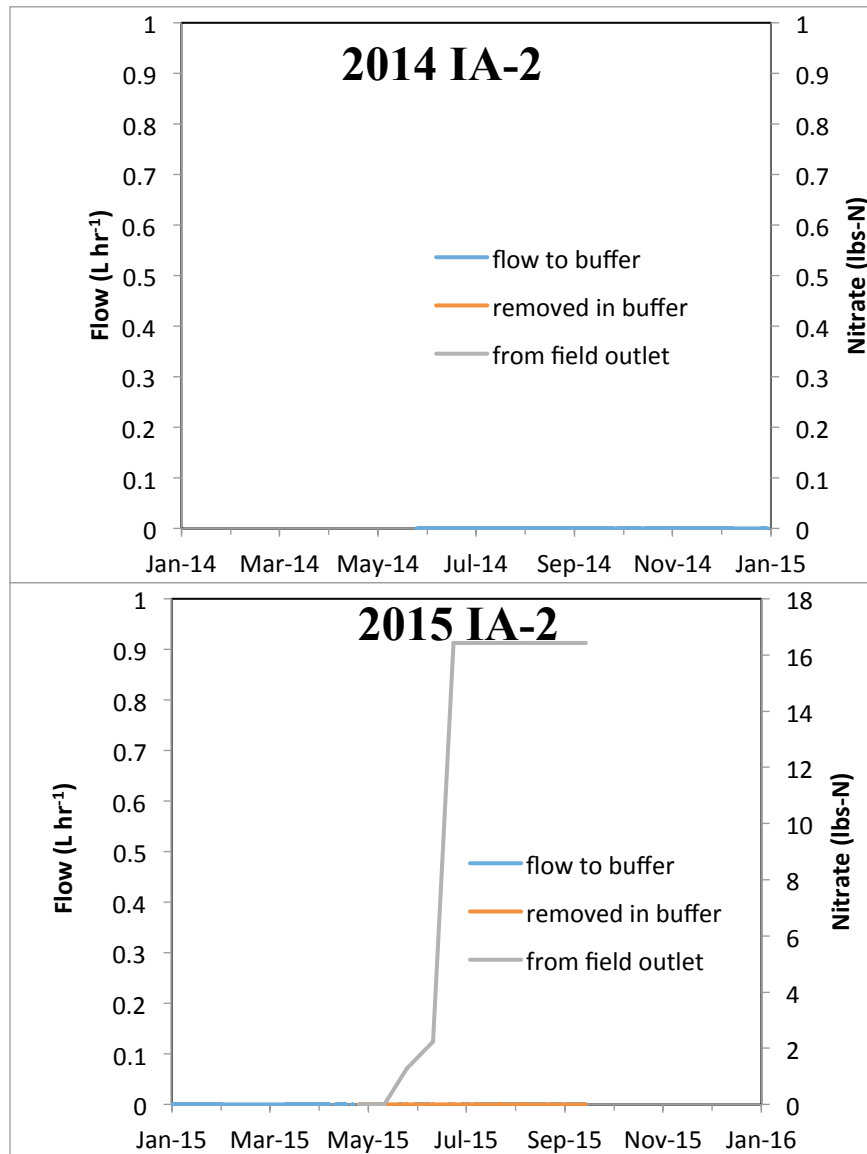
IA-2. No flow to the buffer was measured in either 2014 or 2015, thus we computed no nitrate removal within the buffer for these years. Lack of flow to the buffer is very likely due to inaccuracies in the flow measurements over the control box flashboards rather than there being no physical flow to the buffer distribution pipe. In addition, no usable flow were recorded in 2014, while in 2015 we computed only 16 lbs of N as nitrate leaving through this field tile outlet.

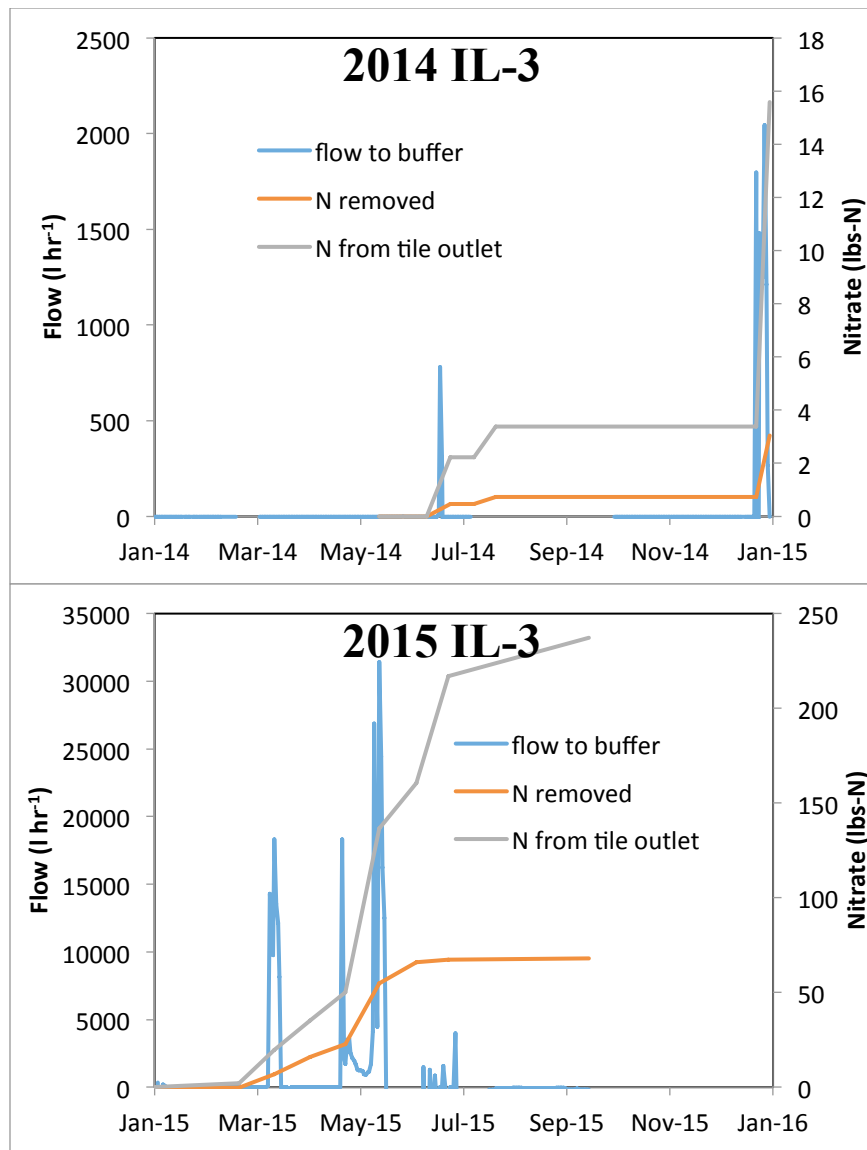
IL-3. In 2014 only a couple of flow events to the buffer were recorded and there were breaks in the flow measurement record. Total nitrate-N loss through the field tile outlet for these periods was 15.6 lbs of which 3 lbs were removed in the buffer for a 19.5% removal rate. In 2015, a longer flow period was recorded and nitrate-N removal within the buffer totaled 68 lbs, which was 28.7% of the 237 lbs of nitrate-N leaving through the field tile outlet. For the two years, 71 lbs of nitrate-N was removed in the buffer that would have otherwise discharged directly into the stream.

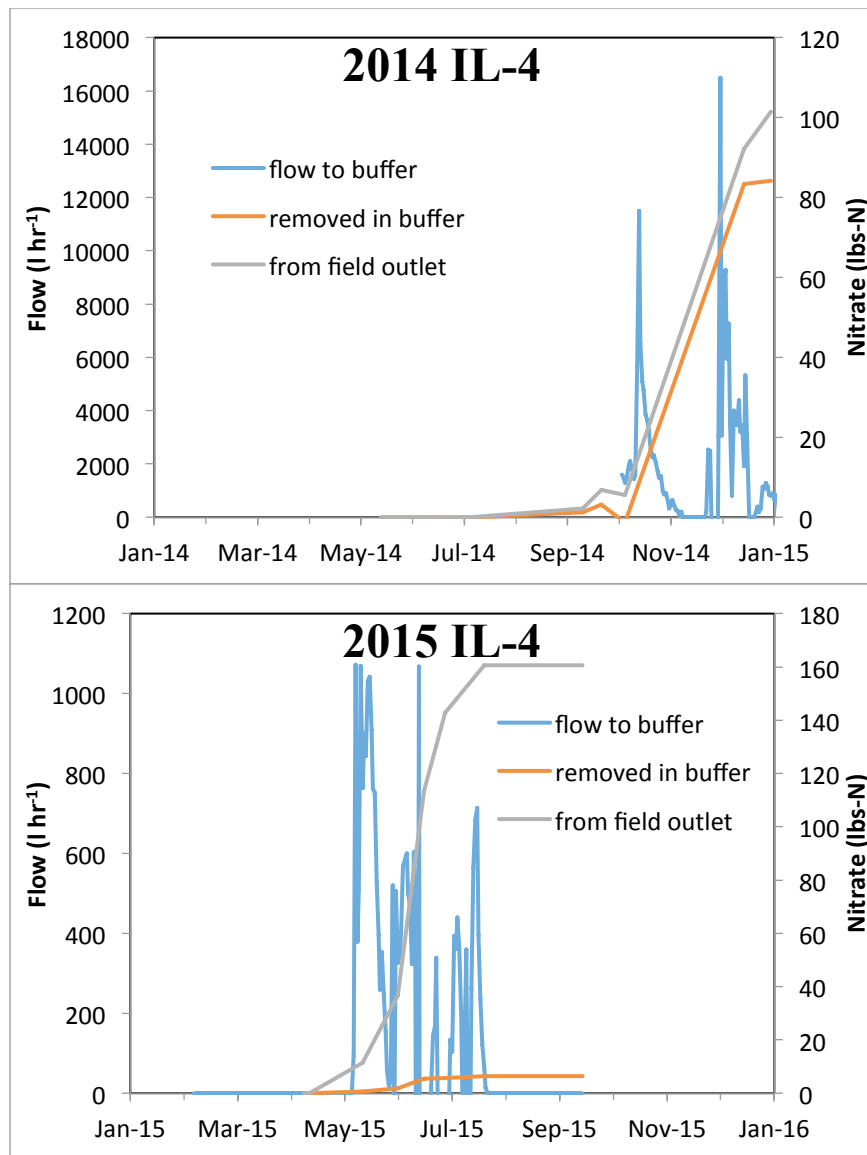
IL-4. In 2014, we were able to measure flow for only the latter quarter of the year. During this time, 91% of the tile flow was redirected into the buffer and the buffer removed 84 lbs of nitrate-N compared to the 101 lbs lost through the tile outlet, for an 83% removal rate. We appeared to have better flow measurements in 2015 which showed over 160 lbs of nitrate-N leaving the tile outlet, but only 6.4 lbs being removed in the buffer. This 4% removal rate was due in part to only 13% of the tile flow being redirected into the buffer and only about a 50% nitrate removal rate within the buffer as determined by the decrease in nitrate concentrations in the observation wells across the buffer.

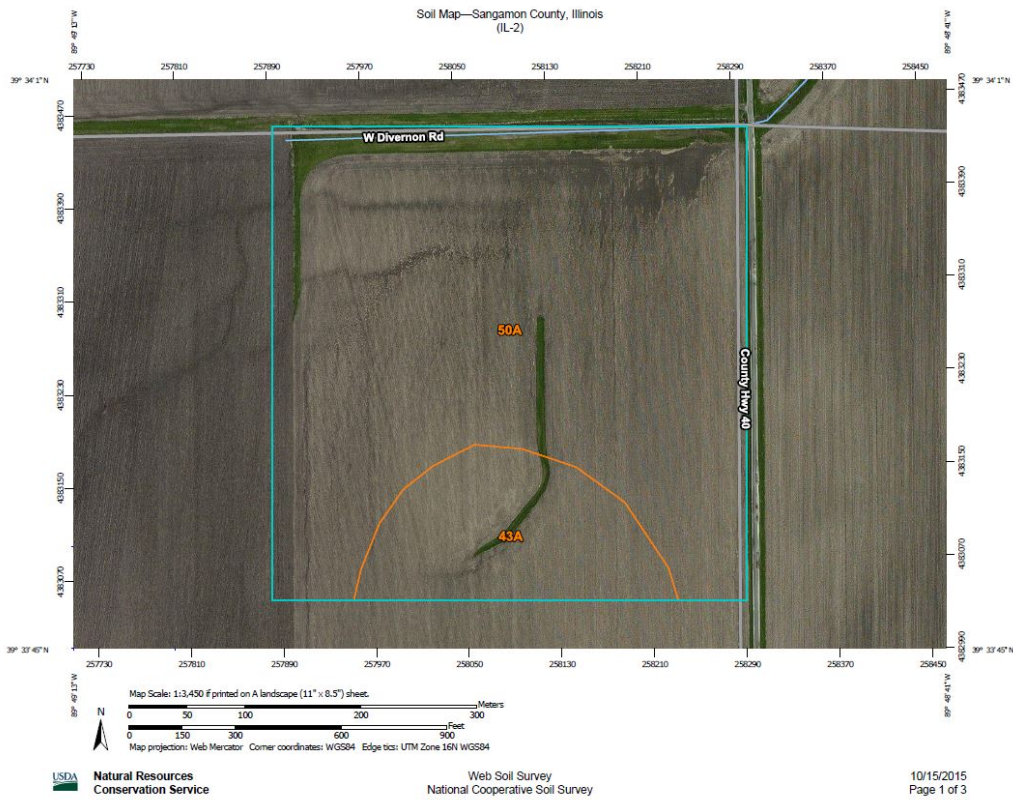
The soil map and soil series are below. Soils in the buffer are mapped as Virден silty clay loam. Soil cores showed the soil to be a silty clay loam down to 42 inches. Below this depth the soil showed evidence of saturation starting at 30 inches on the east side of the buffer grading to 67 inches on the west side. High chroma redoximorphic concentrations above these depths indicate periodic saturation.

Map Symbol	Unit Name
43A	Ipava Silt Loam, 0-2% slopes
50A	Virден Silty Clay Loam, 0-2% slopes

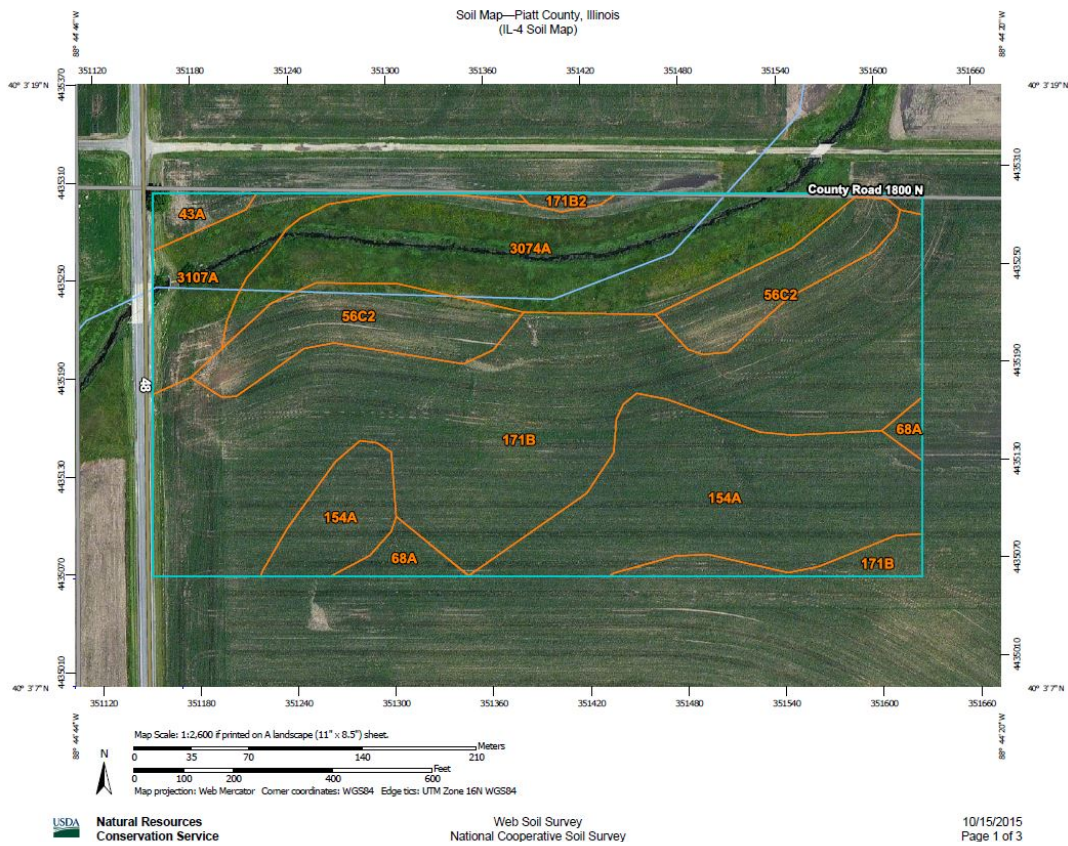
The soil map and soil series are below. Soils in the buffer are mapped as Radford silt loam. Soil cores showed the soil to be a silt loam to or clay loam down to 42 inches. Below 63 inches the soil was gleyed indicative of saturation. No coarse-textured layers were encountered.

Map Symbol	Unit Names
43A	Ipava Silt Loam, 0-2% slopes
56C2	Dana Silty Clay Loam, 5-10% slopes, eroded
68A	Sable Silty Clay Loam, 0-2% slopes
154A	Flanagan Silt Loam, 0-2% slopes
171B	Catlin Silt Loam, 2-5% slopes
171B2	Catlin Silt Loam, 2-5% slopes, eroded
3074A	Radford Silt Loam, 0-2% slopes, frequently flooded
3107A	Sawmill Silty Clay Loam, 0-2% slopes, frequently flooded
