Demonstrate and Evaluate Saturated Buffers at Field Scale to Reduce Nitrates and Phosphorus from Subsurface Field Drainage Systems

NRCS CIG: Grant # 69-3A75-11-205

Date of Submission: December 15, 2015

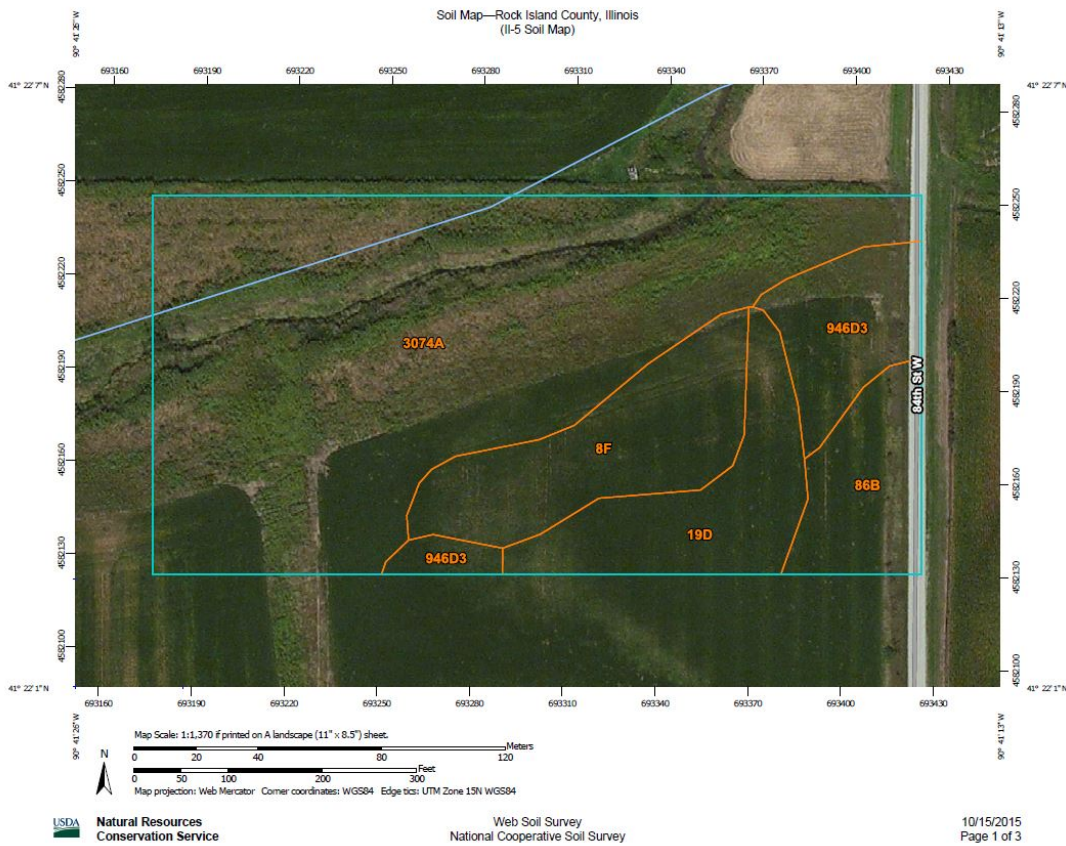
The soil map and soil series are below. Soils in the buffer are mapped as Radford silt loam. Soil cores showed the soil to be silt loam to silty clay loam down to 42 inches. At about 59 inches the sandy soil was gleyed indicative of reducing (saturated) conditions.

Map Symbol	Unit Name
8F	Hickory Silt Loam, 18-35% slopes
19D	Sylvan Silt Loam, 10-18% slopes
86B	Oscos Silt Loam, 2-5% slopes
946D3	Hickory-Atlas Complex, 10-18% slopes, severely eroded
3074A	Radford Silt Loam, 0-2% slopes, frequently flooded

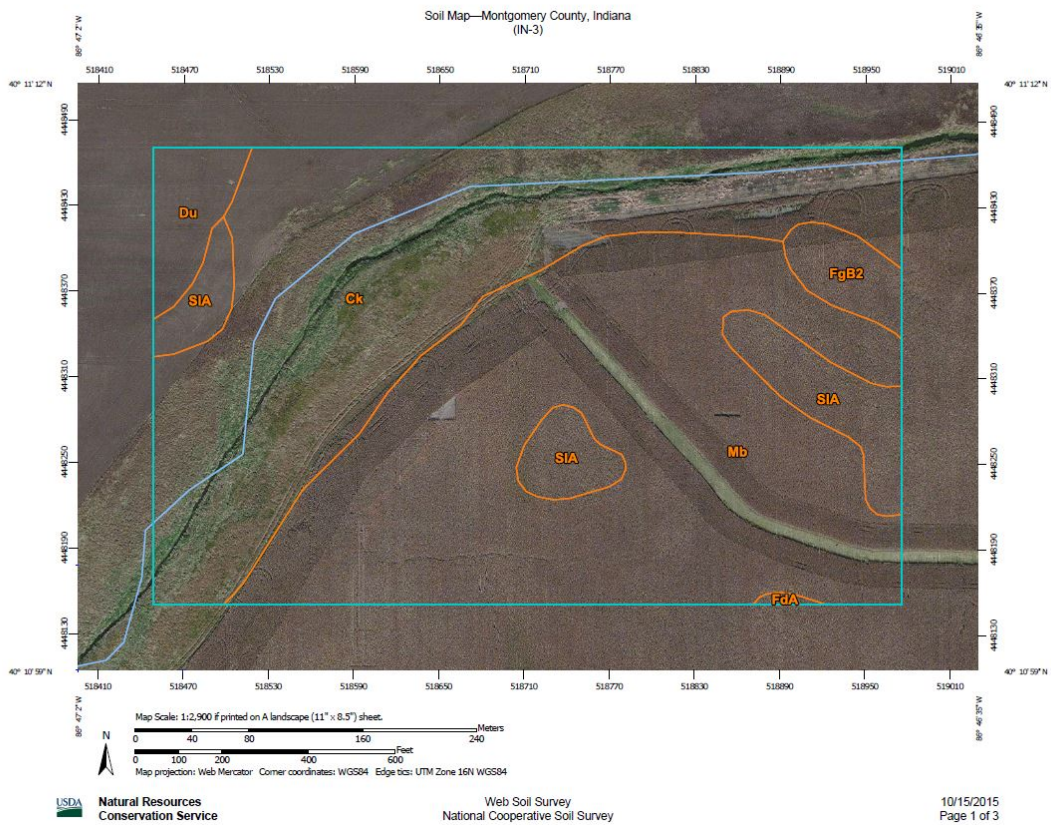
The soil map and soil series are below. Soils in the buffer are mapped as Cohoctah loam. Soil cores showed the soil to be loam to silt loam down to 42 inches. On the eastern and western ends of the buffer a gleyed layer with high chroma redoximorphic features indicative of saturated conditions was present starting at about 35 inches. At about 67 there appeared to be a calcareous buried A horizon. The middle of the buffer was calcareous starting at 12 inches and had a sandy layer starting at 39 inches. Below the sand was also a buried calcareous A horizon below which was a gleyed clay layer.

Map Symbol	Unit Name
Ck	Cohoctah Loam, frequently flooded
Du	Drummer Silty Clay Loam
FdA	Fincastle Silt Loam, Tipton Till Plain, 0-2% slopes
FgB2	Fincastle-Miami Silt Loams, 2-6% slopes, eroded
Mb	Mahalasville Silty Clay Loam
SIA	Starks Silt Loam, 0-2% slopes

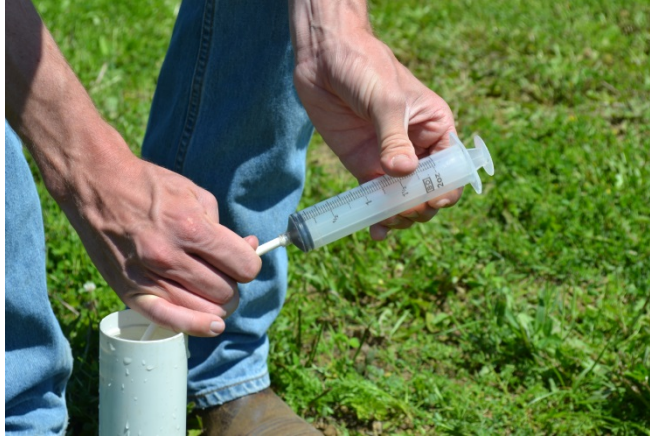
1-C: Slowly pull the plunger all the way up and draw water into the syringe

- a. Because some sediment may settle to the bottom of the well, pull up on the tube a few inches before you draw up the water into the syringe. This will help keep sediment out of the water make it easier to filter

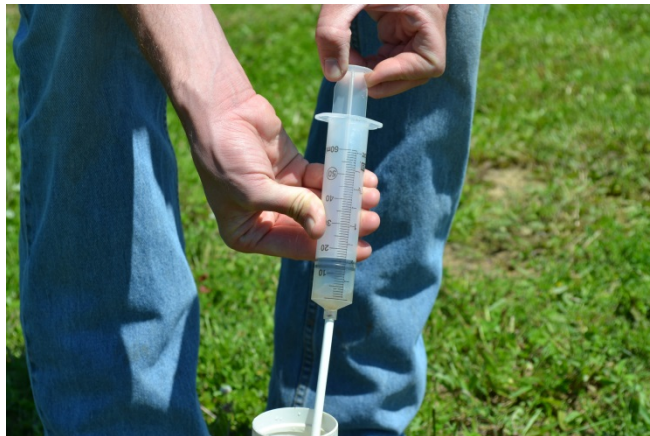
1-D: Disconnect the syringe from the sampling tube

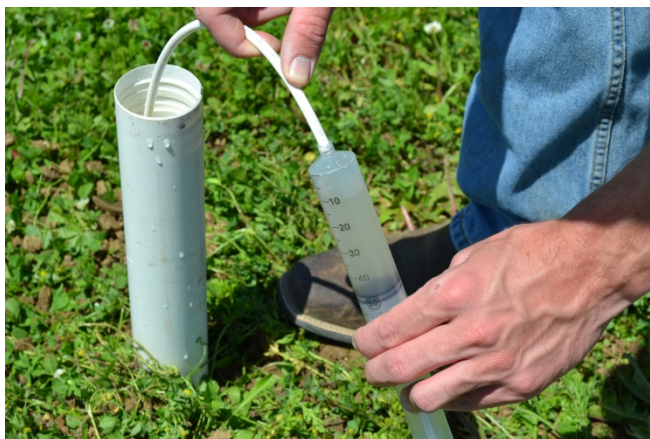
1-E: Place finger over the tip of the syringe and shake, rinsing the inside of the syringe with the water

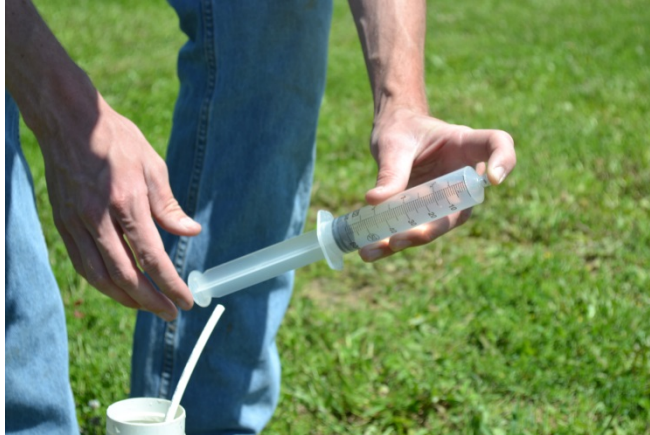
1-F: Point the tip of the syringe downward and squirt all the water out

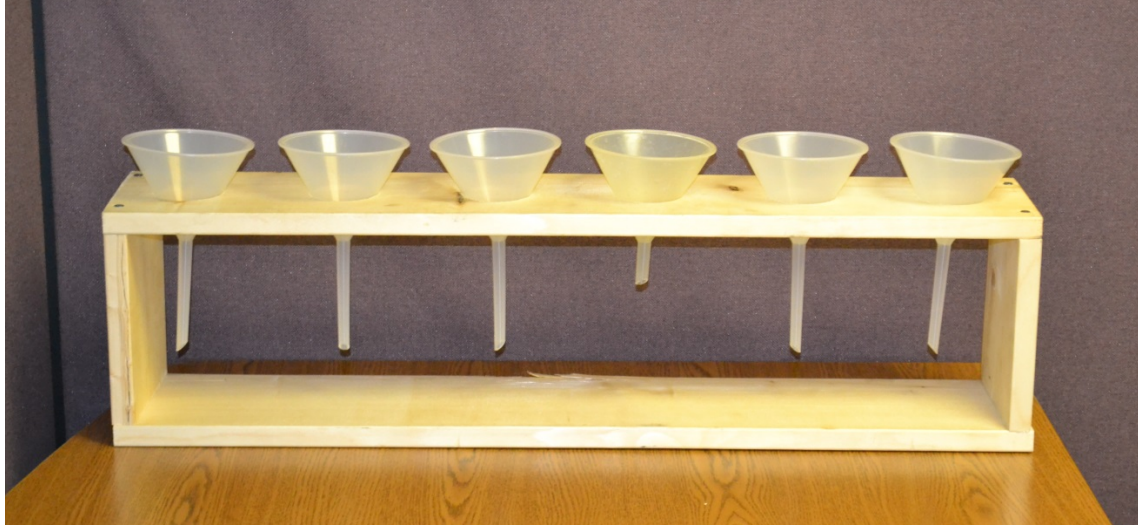
2-A: Set up funnel racks

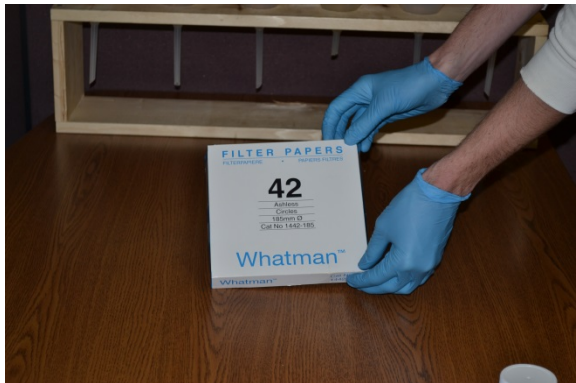
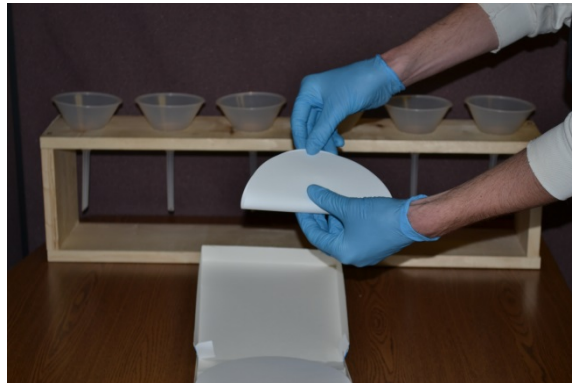
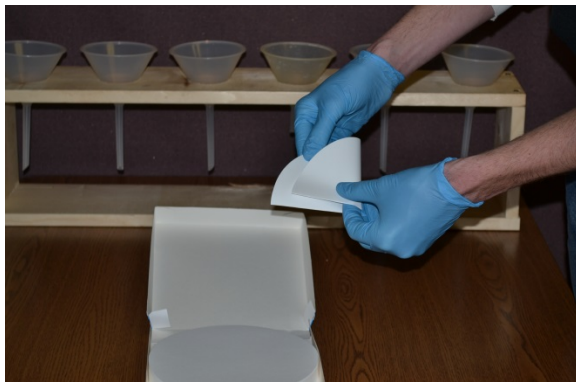
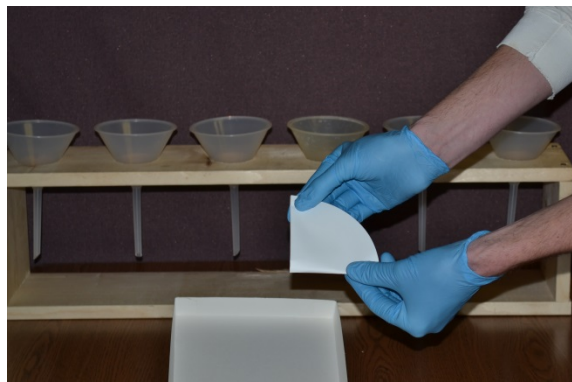
2-B: Wearing gloves, fold the filter paper

- a. Fold in half, then half again
- b. It is best to hold the paper in the air when folding as the countertop is a potential source of contamination
- c. Only use the filter paper that has been supplied by the ADMC

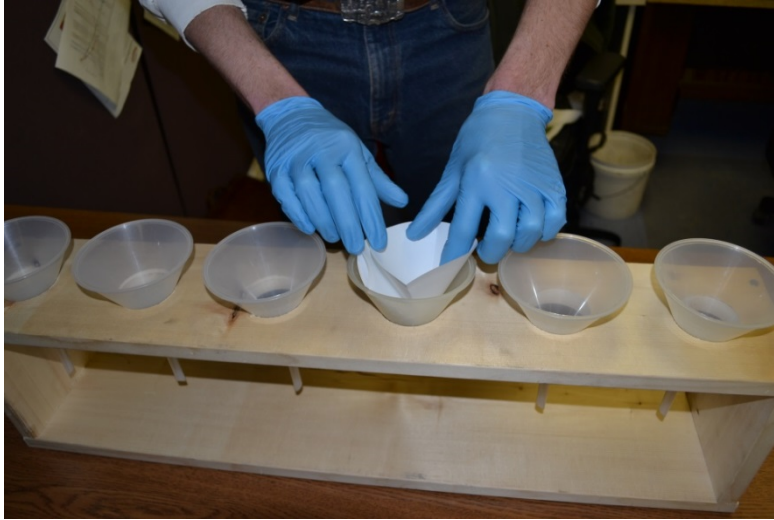
- 2-C: Place the filter paper in the funnel
a. Set the paper so that water will not be able to bypass the filter paper

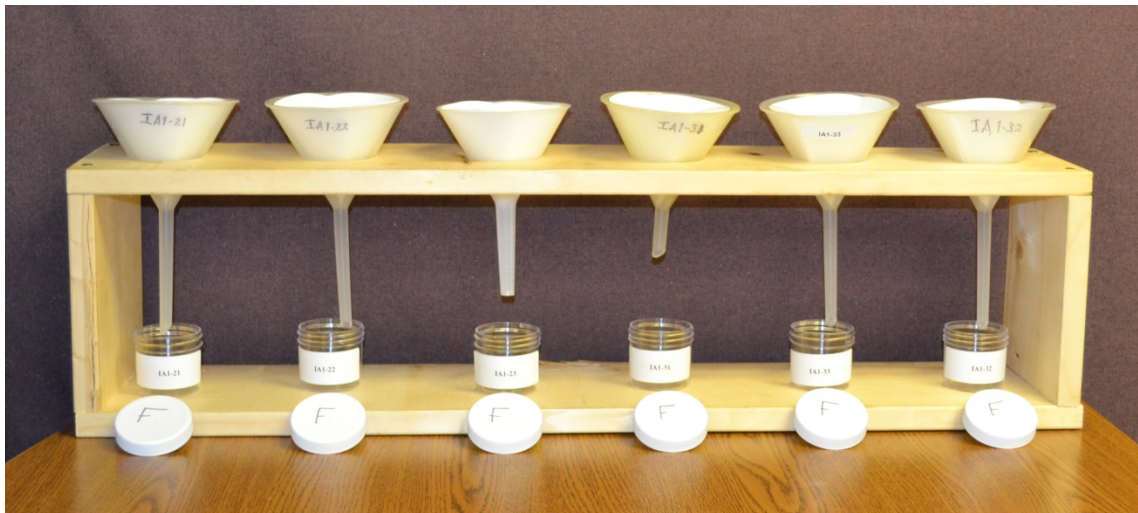
- 2-D: Place a filter jar under the corresponding funnel

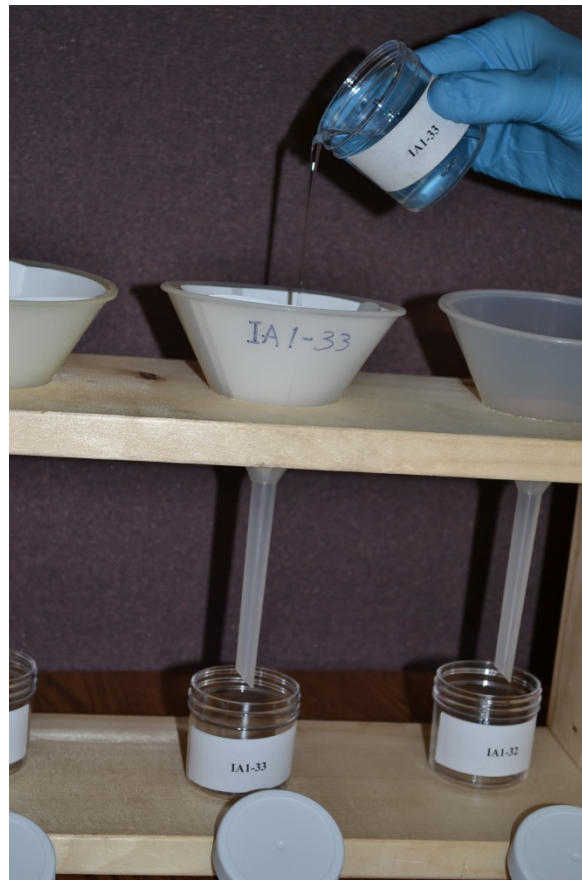
- 2-E: Empty contents of transfer jar into corresponding funnel
a. Keep the water level below the top of the filter to prevent water bypassing the filter

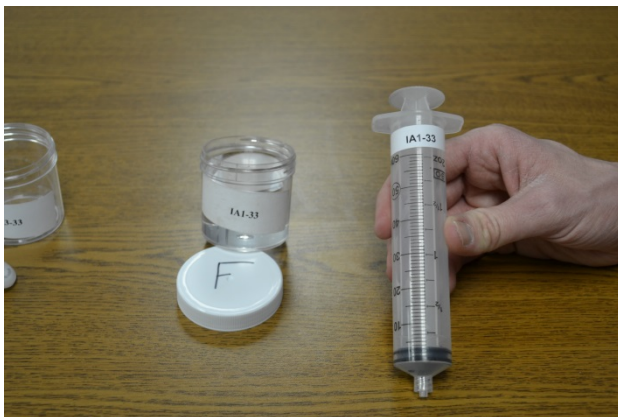
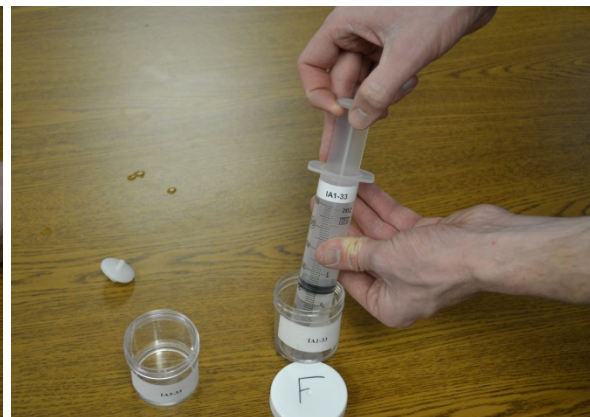
- 2-F: Filtering will take approx. 30 to 45 minutes
2-G: Using the corresponding syringe, pull the water out of the filter jar

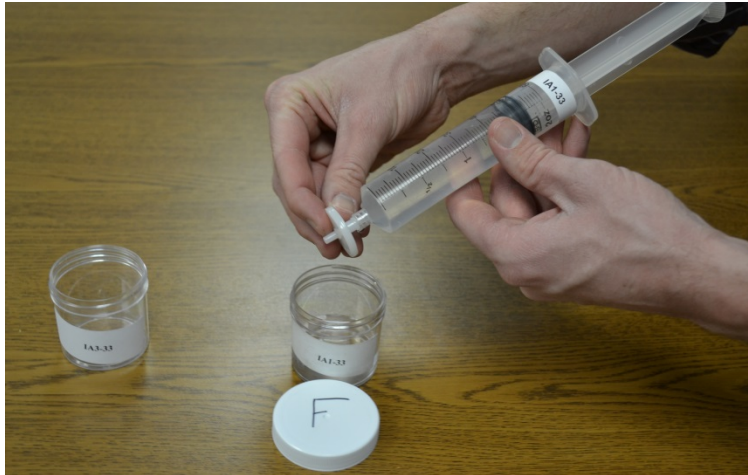
2-H: Connect the filter cartridge to the syringe

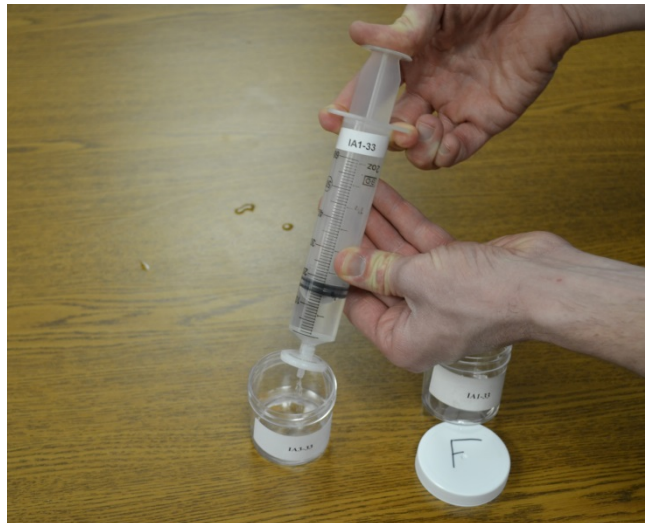
2-I: Push the water through the filter and into the final sample jar
a. Only 50mL of water need to be filtered into the sample jar

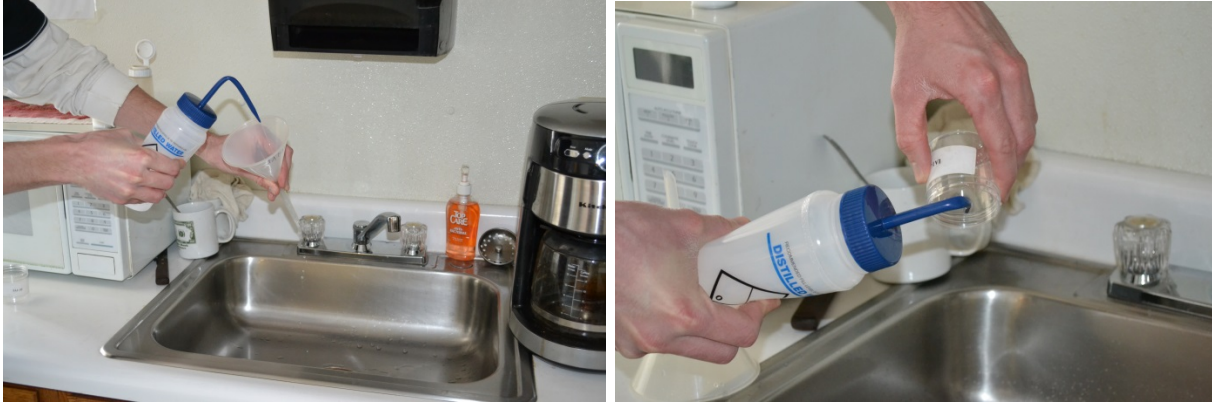
2-N: Rinse all transfer jars, funnels, syringes, and filter jars with distilled water

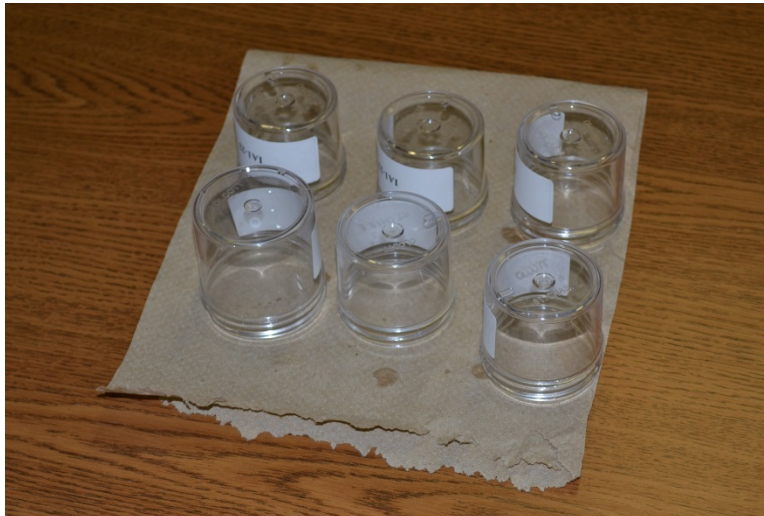
2-O: Allow all jars, funnels, and syringes to fully dry before putting away
a. Air dry only!

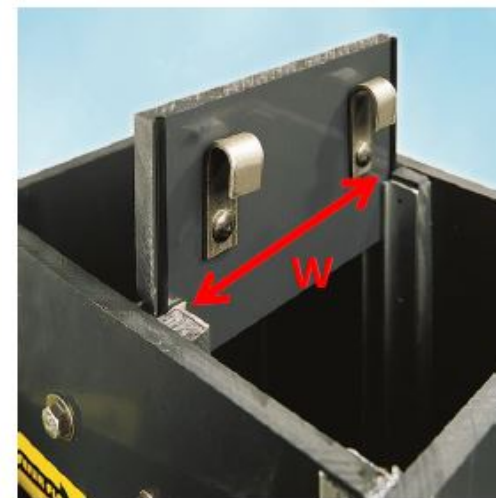
C = distance from bottom of the structure to the top of the water, measured using the pressure transducer

Z = distance from the top of the structure to the bottom of the structure

W = width of the weir. This value is manufactured to a consistent width, dependent on the size of the structure.

H = height of water above the stop logs **$H = C - B$**

Stop logs with a V-notch cut into it can also be used for more accurately measuring low-flow conditions. The distance from the top of the stop log to the bottom of the V-notch is 6.56 inches, regardless of structure size. In this case, H is the height of water above the bottom of the V-notch. The V-notch is 45° and has a rounded bottom.
